**Sacramento River Flood Control System Evaluation  
Initial Appraisal Report - Lower Sacramento Area**

**Basis of Design  
Geotechnical Evaluation of Levees  
February 1993**

BASIS OF DESIGN  
GEOTECHNICAL EVALUATION OF LEVEES  
FOR  
SACRAMENTO RIVER FLOOD CONTROL SYSTEM EVALUATION  
LOWER SACRAMENTO RIVER AREA, PHASE IV

PREPARED BY  
SOIL DESIGN SECTION, GEOTECHNICAL BRANCH  
U.S. ARMY ENGINEER DISTRICT, SACRAMENTO  
CORPS OF ENGINEERS

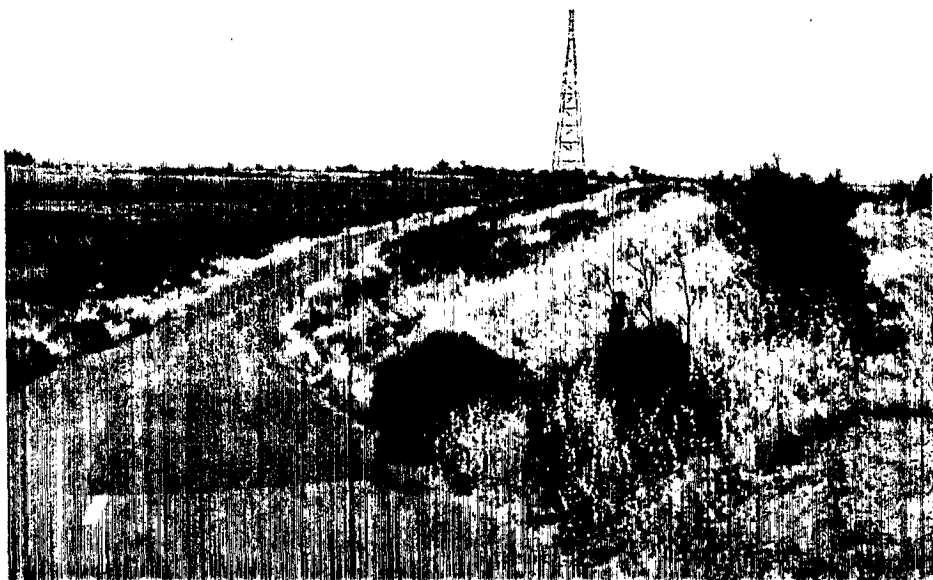
The levees in the Sacramento River portion of this reach were raised from 1 to 5 feet in 1954. During this construction and again in 1955 several levee slope failures occurred primarily between approximately R.M. 3.75 and R.M. 4.5. The 1955 failures involved up to 4 feet of slumping of the levee crown and bulging of the landside toe area. Site 341-5, which is within this reach, is approximately 1/2 mile in length. Again in 1965, additional slumping occurred in this same area. As indicated on Figure 15, this is also an area of thick peat deposits which likely contributed to the failures. No serious slumping has been reported since the 1965 repairs were completed. As part of the 1965 repairs, the county road was moved off of the levee crown (Photo 1).

Photo 1 SITE 341-5 Looking downstream from where county road was moved off of levee crown in 1965. 5/22/92

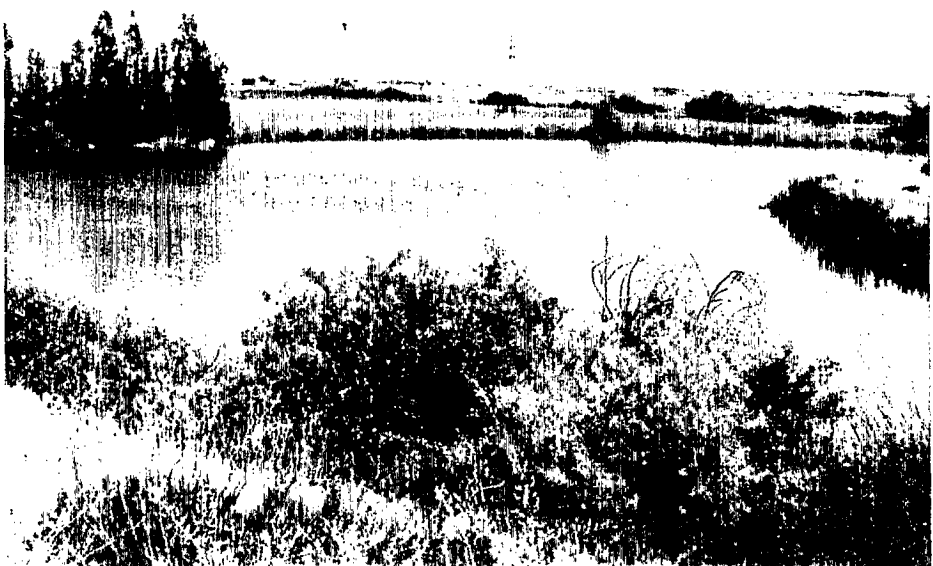
Seepage has been reported at three other sites including 341-2, 341-3, and -3A. A 1930's levee failure (Site 341-4) occurred in Horseshoe Bend. The levee failure resulted in a large landside scour pond (Photo 3). It was reported in the phase two study that Site 341-4 seeps all year. Seepage was also reported along the 2-mile reach of the west levee of Threemile Slough. This reach is identified as Site 341-1. The east bank levee of Threemile Slough (Site 1601-1) has a history of slumping following 4 to 5-foot raising in 1954. Numerous stability and subsidence problems continued to occur in this reach until it was completely turned over to the State Reclamation Board in 1955. In the early 1980's a low toe berm

Site 341-4 is the site of a 1930's levee breach. A very large scour pond remains in this location. It is likely that seepage from Horseshoe Bend enters into the pond through the levee foundation. However, there were no indications of near surface seepage during the site inspection. The levee crown at this location is approximately 100 feet wide. No repairs are recommended.

Photo 3 SITE 341-4 Scour pond created by 1930s' levee break. 5/22/92

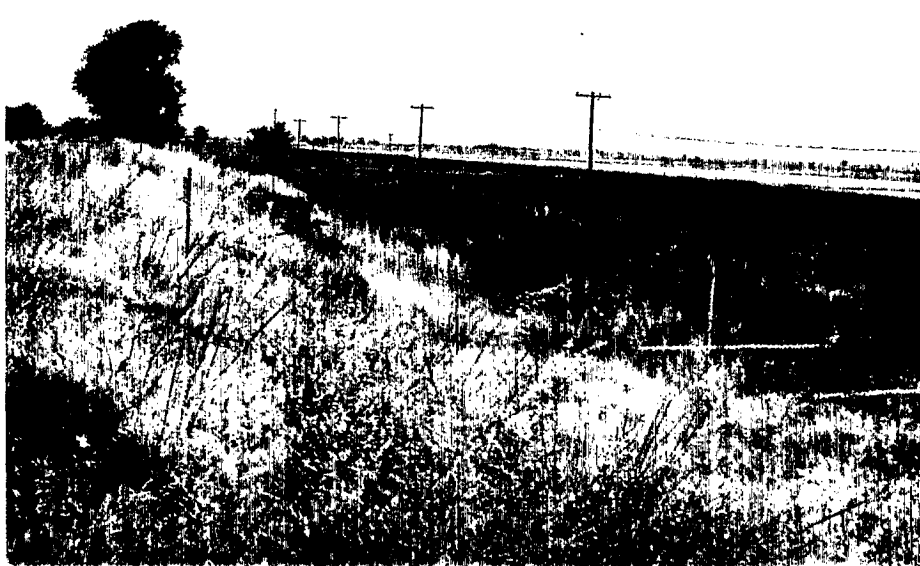
Photo 4 SITE 563-1 Seepage along levee landside toe. 5/22/92

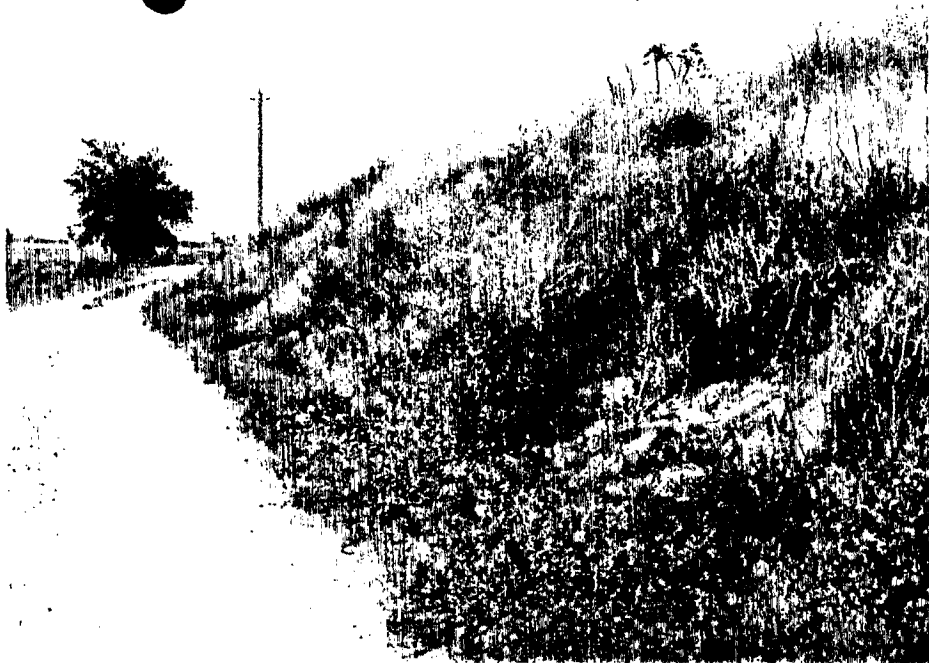
Photo 5 SITE 563-2 Sloughing along landside slope. 5/22/92

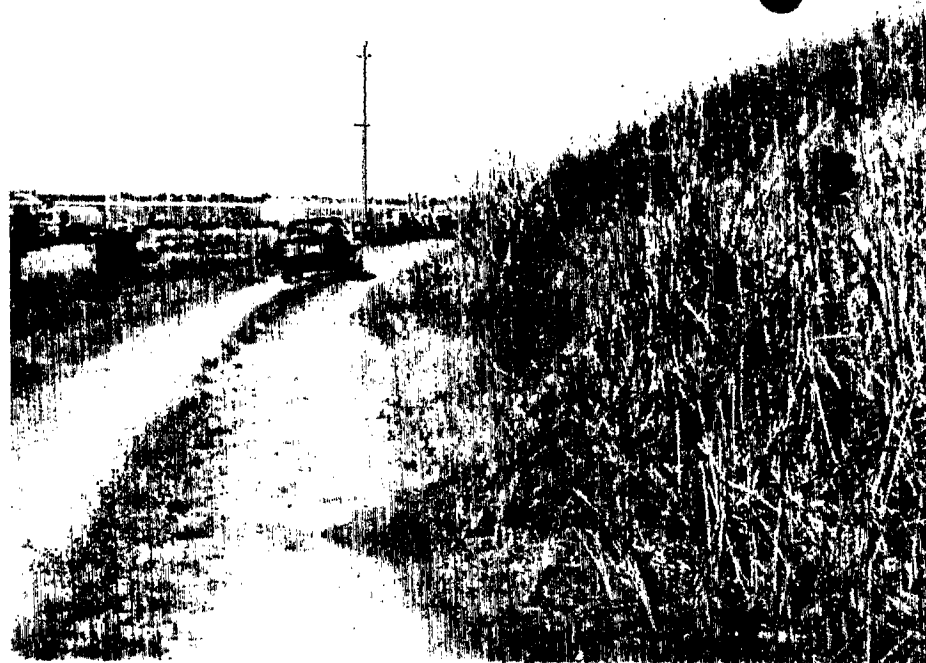
Photo 6 SITE 563-2 Seepage along levee landside toe. 5/22/92

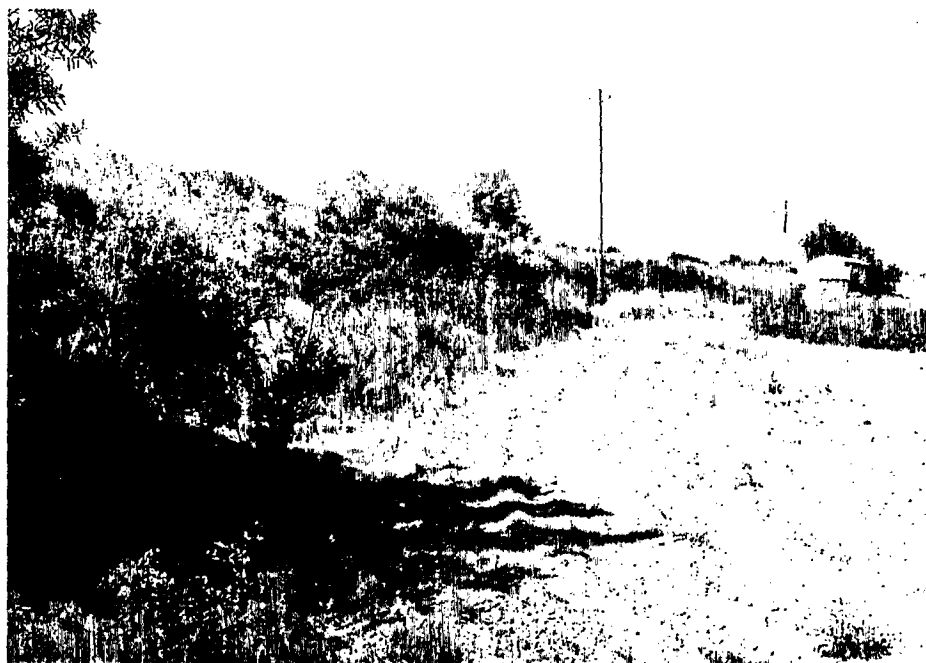
Photo 8 SITE 556-2 Seepage along right bank levee in irrigation ditch. 5/22/92

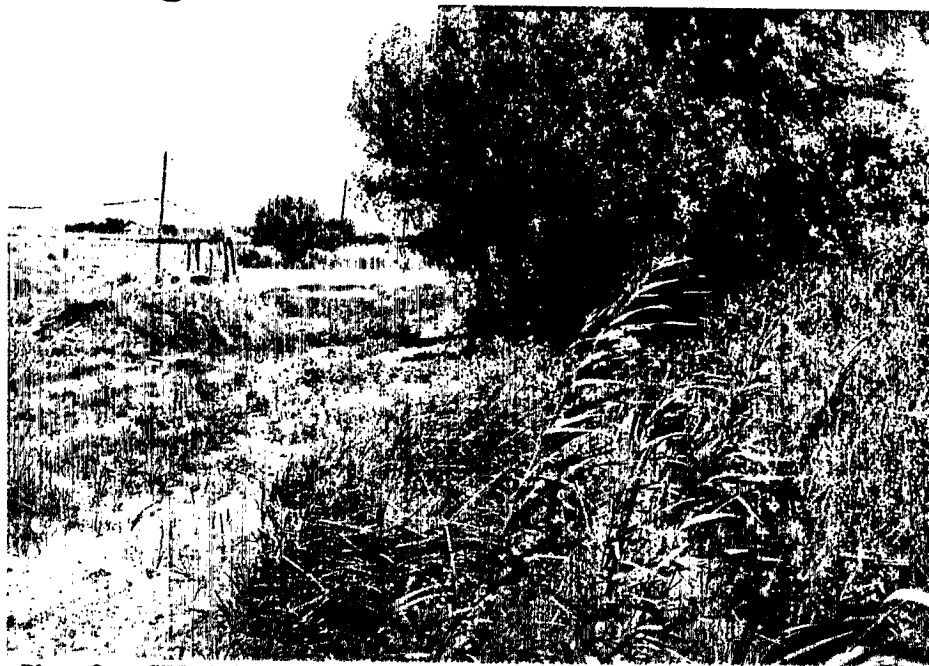
Photo 9 SITE BA-1 Severe seepage along levee toe. 6/3/92

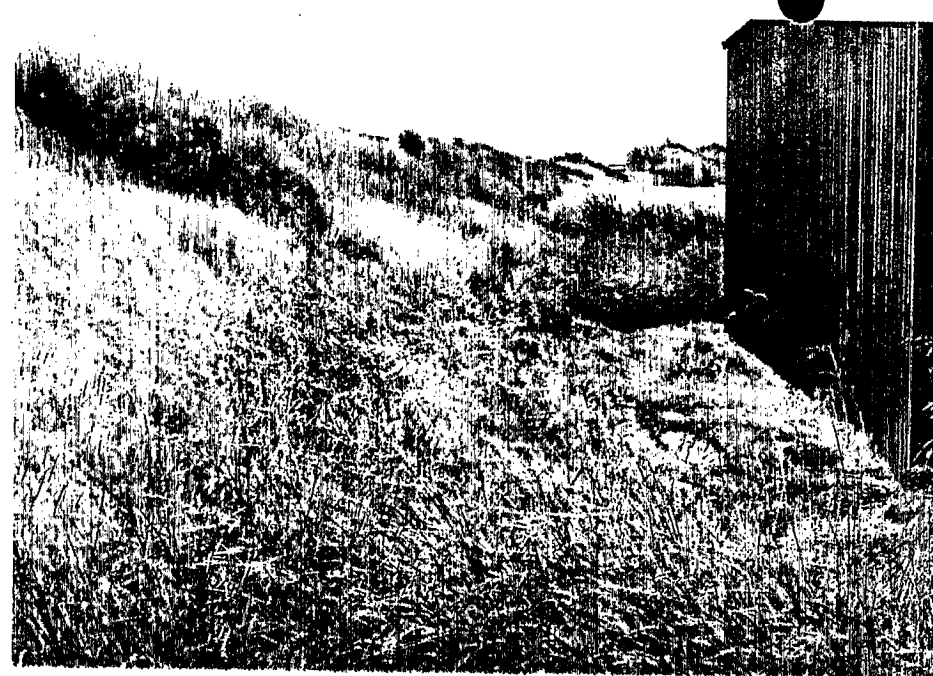
Photo 10 SITE BA-1 Seepage along levee toe. Note standing water. 6/3/92

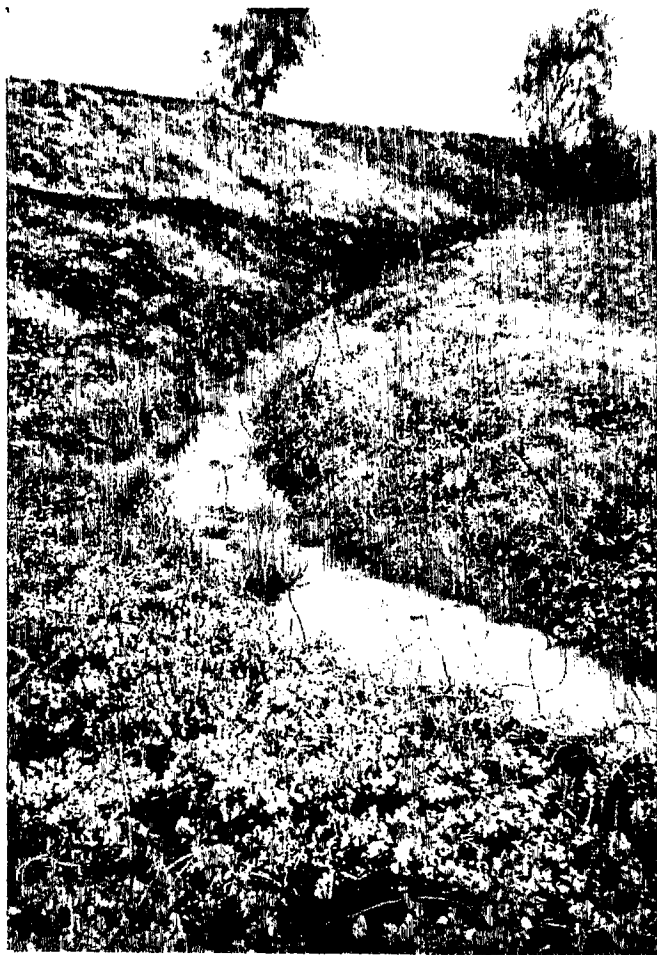
Photo 13 SITE 349-1 Chronic seepage and sand boils in irrigation ditch.

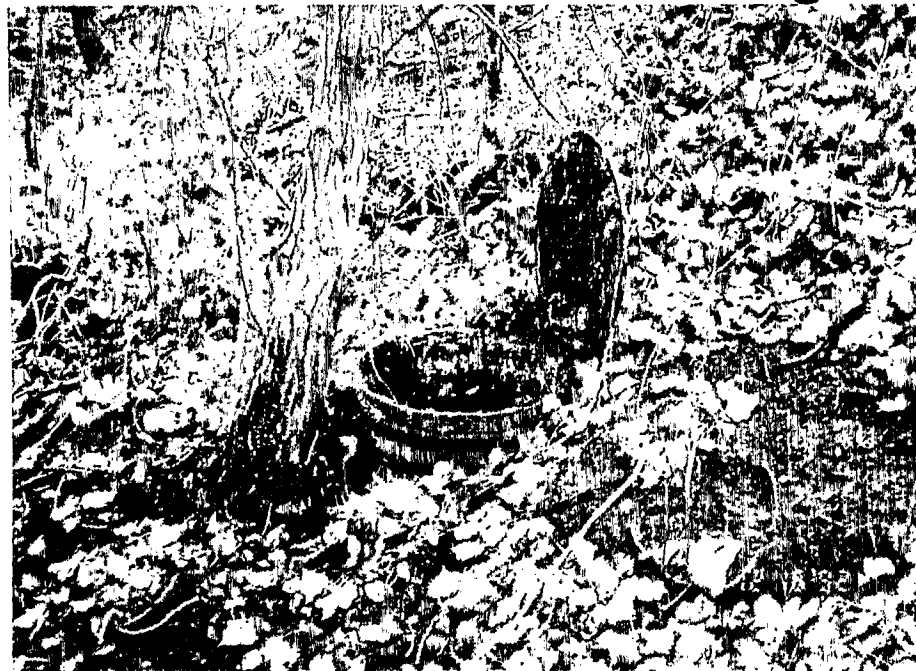
Photo 14 SITE 349-1 Relief well installed in 1956, located along L/S toe, Sutter Slough. 12/16/92

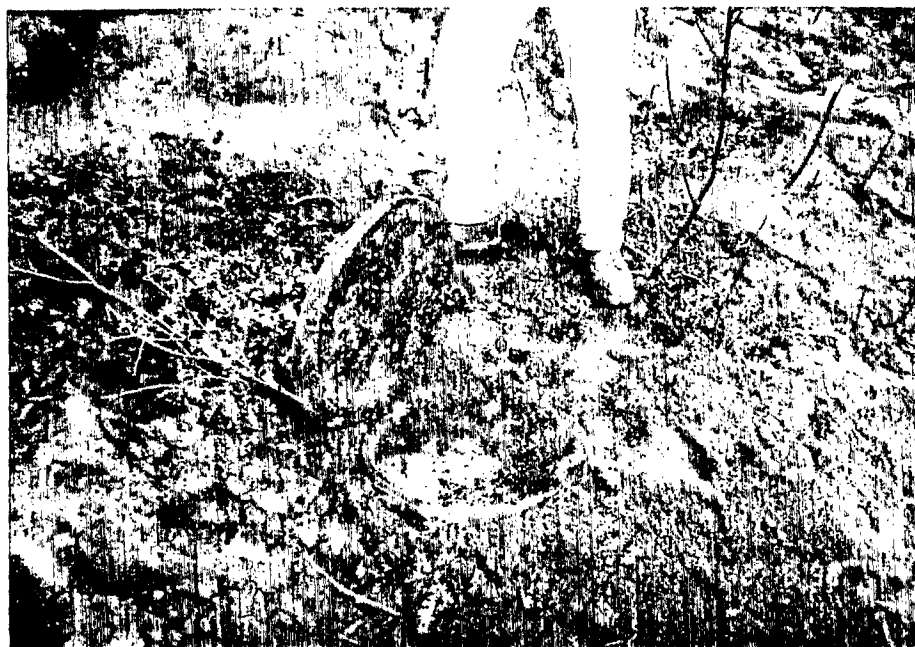
Photo 15 SITE 349-1 Relief well along Sutter Slough L/S toe filled with sand. 12/16/92

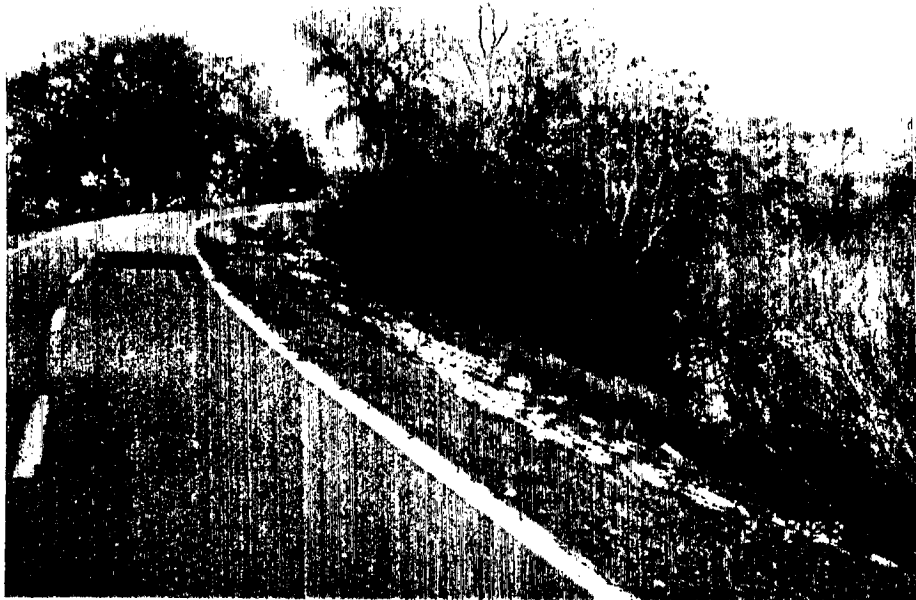
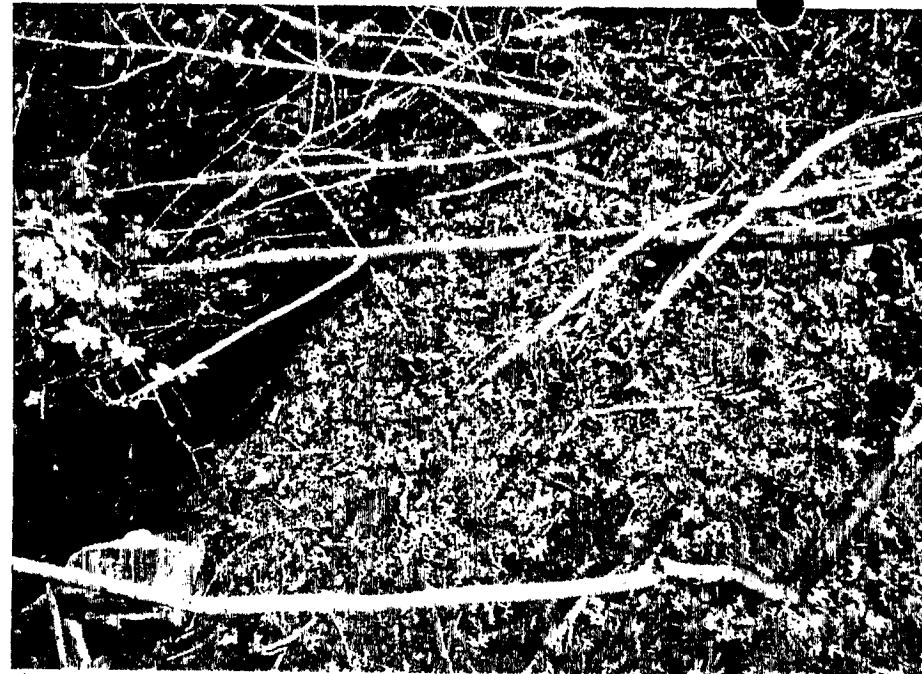
Photo 16 SITE 999-5 Progressive failure and erosion along waterside slope. 2/2/93

Photo 17 SITE 999-5 Closeup of cracks on lower slope with site 999-5. 2/2/93

SITE NUMBER	PROBLEMS/CONCERNS	RECOMMENDATIONS	SITE LENGTH	PHOTO NUMBER
999-5	Erosion and sloughing of lower portion of waterside slope	Place stonefill and riprap the lower portion of waterside slope	500 feet (Note 1)	16 & 17
2098-10	Significant erosion and slumping of landside slope	Restore lower portion of landside slope and provide slope protection	2500 feet	23
2068-1	Landside berm deteriorating and causing decrease in levee stability	Restore landside slope and provide slope protection	2500 feet	25 & 26
2068-2	Landside and waterside berms deteriorating and causing decrease in levee stability	Restore landside berm and provide slope protection to both landside and waterside berms	1.9 miles	-
2060-3A	Slope Failure	Excavate and reconstruct failed levee section	100 feet	29
2098-8	Large erosional scarps on waterside bank and portion of levee slope	Repair with rockfill and riprap slope protection	1500 feet	21 & 22

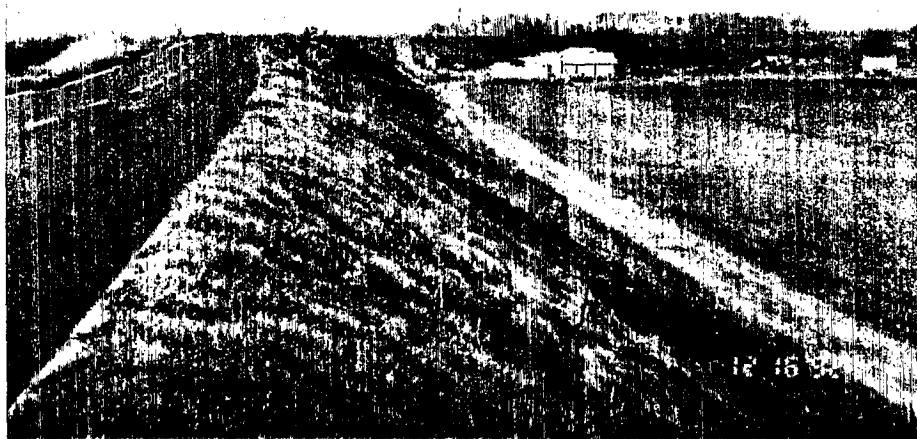
Photo 18 SITE 501-3 Reported seepage in this area during high water stages. 2/16/92

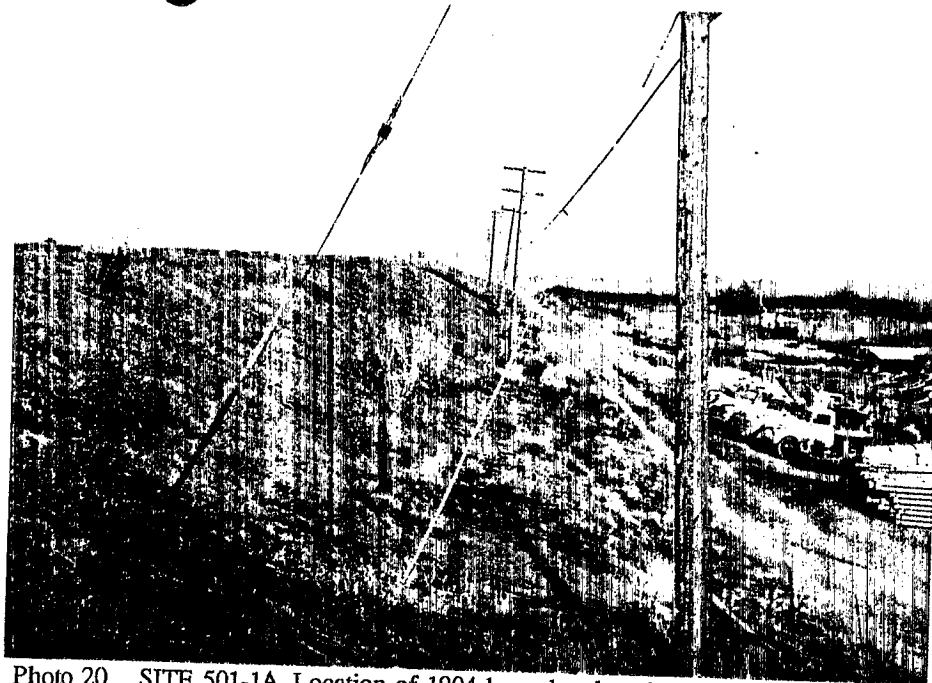
Photo 20 SITE 501-1A Location of 1904 levee break and sand boil on L/S slope in Feb. 1986 12/16/93

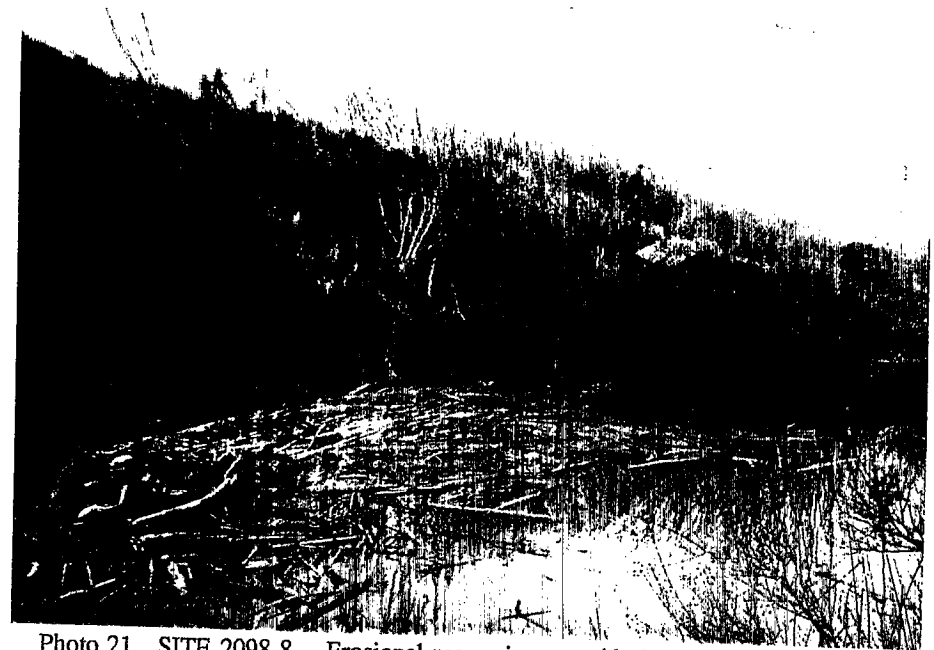
Photo 21 SITE 2098-8 Erosional scarps in waterside bank. 1/5/93

Photo 22 SITE 2098-8 Erosional scarps same area as photo 21. 1/5/93

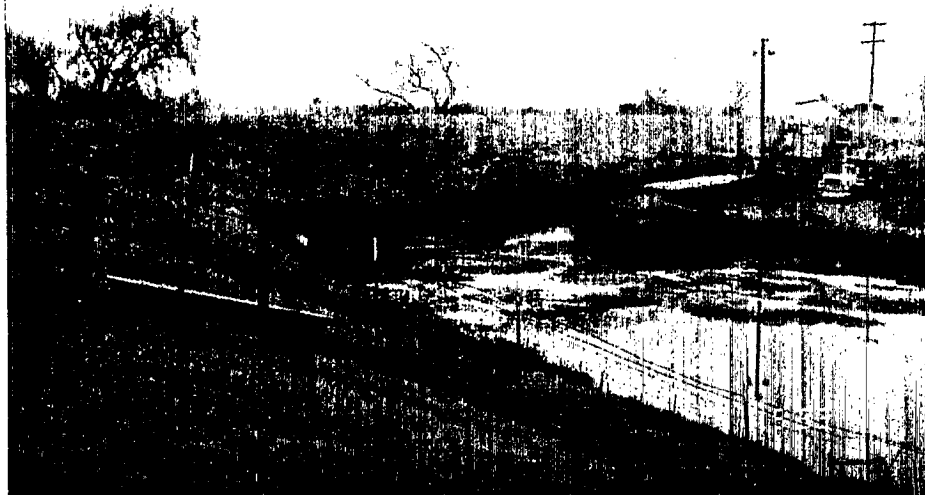
Photo 24 SITE 2098-10A Landside slope failures along 400-foot reach. Note stress cracks in levee slope. 1/5/93

2098-10	Significant erosion and slumping of landside slope	Restore lower portion of landside slope with stonefill and slope protection	2500 feet	23
2098-10A	Unstable landside slope with stress cracks and scattered slumps in slope	Backfill or relocate irrigation ditch to provide stabilizing effect on levee	400 feet	24
2068-1	Landside berm deteriorating and causing decrease in levee stability	Restore landside berm and provide slope protection	2500 feet	25 & 26
2068-2	Landside and waterside berms deteriorating and causing decrease in levee stability	Restore landside berm and provide slope protection to both landside and waterside berms	1.9 miles	-

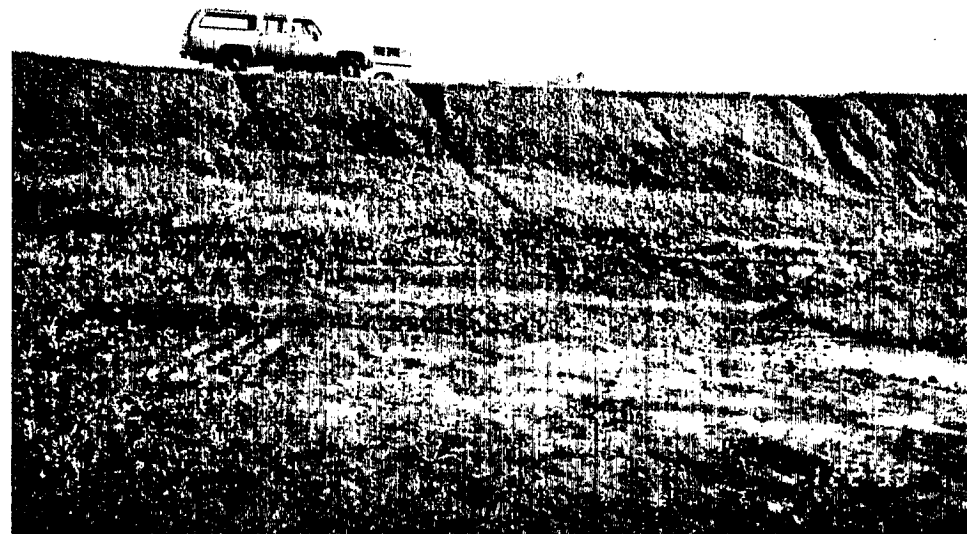
Photo 27 Erosional damage to levee slope from heavy January 1993 rainfall. 1/22/93
